# Safety Bulletin

No. 2005-04-B | October 12, 2006

*BP TEXAS CITY, TX REFINERY FIRE*

## POSITIVE MATERIAL VERIFICATION: PREVENT ERRORS DURING ALLOY STEEL SYSTEMS MAINTENANCE

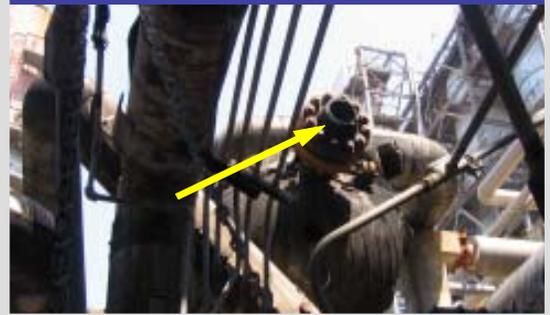
The RHU incident investigation determined that an 8-inch diameter carbon steel elbow inadvertently installed in a high-pressure, high-temperature hydrogen line ruptured after operating for only 3 months. The escaping hydrogen gas from the ruptured elbow quickly ignited.

This incident occurred after a maintenance contractor accidentally switched a carbon steel elbow with an alloy steel elbow during a scheduled heat exchanger overhaul in February 2005. The alloy steel elbow was resistant to high temperature hydrogen attack (HTHA) but the carbon steel elbow was not. Metallurgical analyses of the failed elbow concluded that HTHA severely weakened the carbon steel elbow.

Figure 1. Carbon steel RHU heat exchanger outlet pipe (arrow) ruptured after operating only 3 months in high-temperature hydrogen service.

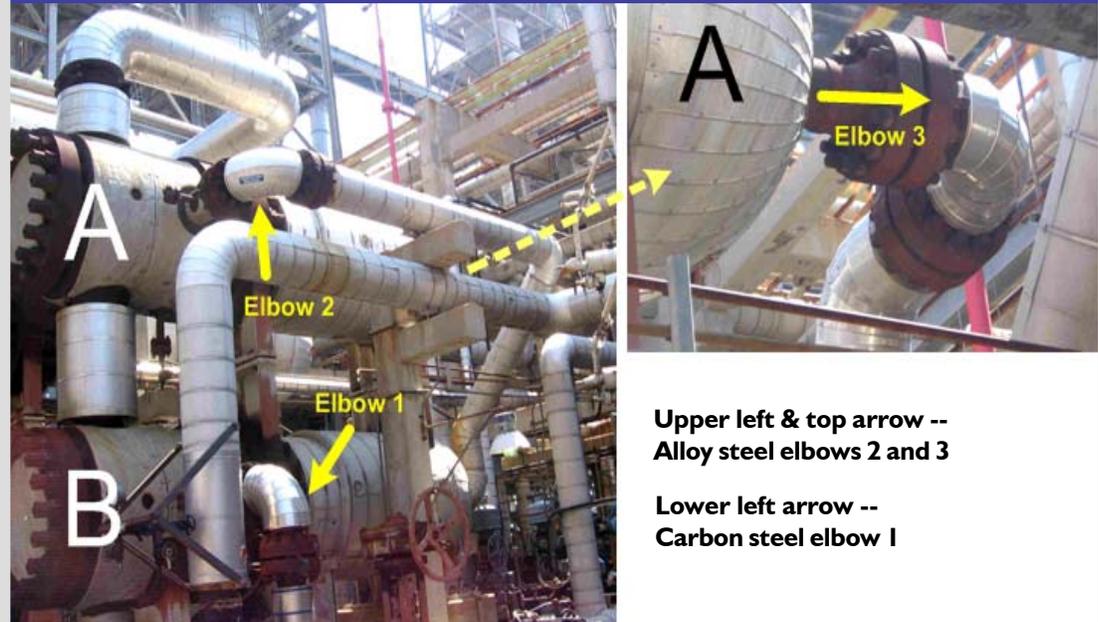
Figure 2. Dimensionally identical piping elbows on RHU heat exchangers A and B.

Construction costs may have been saved by making elbows 1, 2, and 3 on each heat exchanger assembly dimensionally identical, as doing so requires fewer pipe assembly fabrication drawings and weld joints in each assembly. Because the elbows are dimensionally identical, the piping contractor had to ensure that the low alloy steel elbows 2 and 3 were installed in the correct locations when the RHU was built. Had the elbow 1 design

dimensions been different, elbow 1 would not have been interchangeable with elbow 2 or 3 (see Figure 2).

Because of this component interchangeability, any heat exchanger piping disassembly/reassembly for maintenance or repair requires the maintenance crew to be careful to install each elbow in the correct location. Because carbon steel and low alloy steel are visually indistinguishable, special test equipment<sup>6</sup> is needed to distinguish the two low alloy steel elbows from the carbon steel elbow. Otherwise, to prevent switching elbow 2 or 3 with incompatible carbon steel elbow 1, the crew must clearly label or mark each elbow before removing them, then confirm that each has been reinstalled in the correct location.

- Piping systems can be designed such that incompatible components cannot be interchanged. All three elbows could have been made from the same low alloy steel material, even though this would have meant additional material expense. Alternatively, elbow 1 could have been dimensionally different from elbow 2 and 3, although this would have meant additional construction costs.

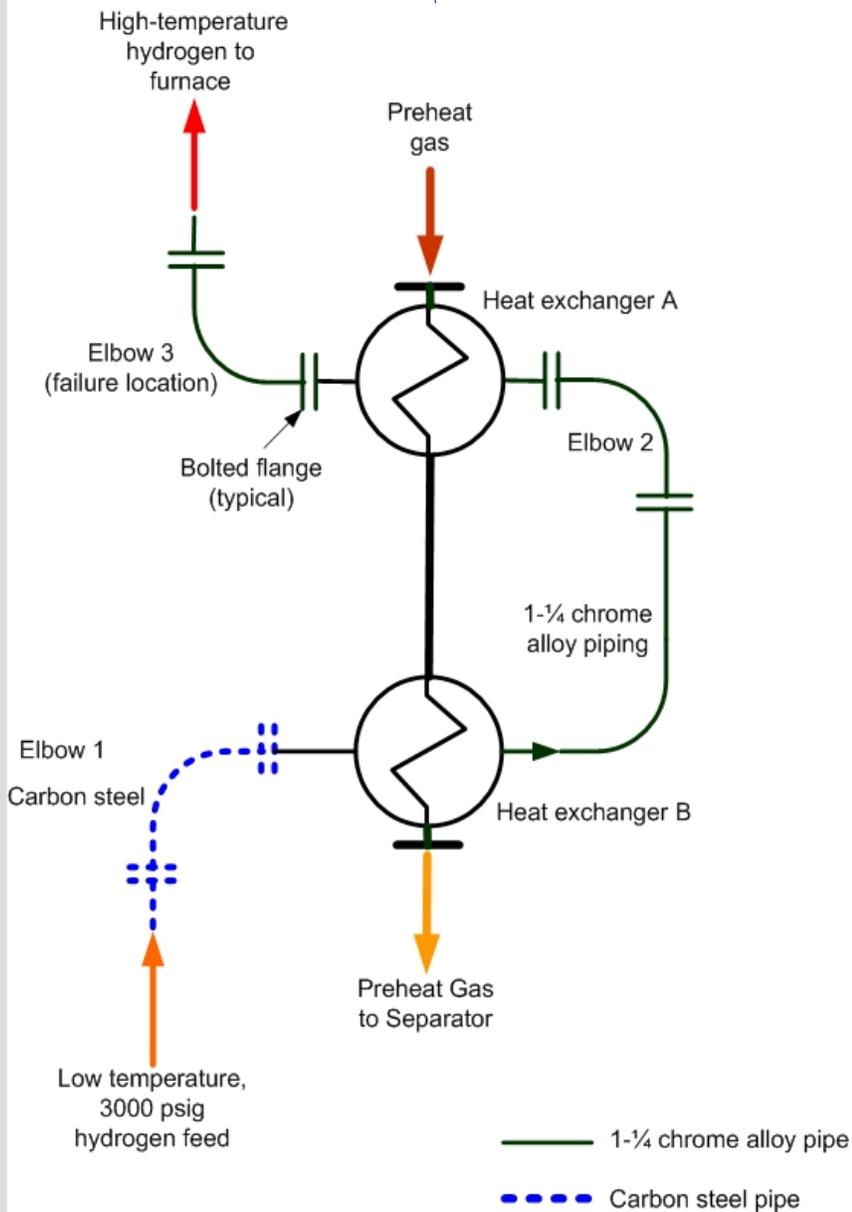
Designed in the early 1980s, the RHU has three parallel operating systems. Each system contains a heat exchanger assembly that consists of two series-connected heat exchangers to preheat the hydrogen. For high-temperature hydrogen gas service piping to resist HTHA, the piping design specification requires 1.25% chrome “low alloy” steel, but for piping in hydrogen service at low temperatures, or those below 450°F, non-HTHA resistant carbon steel is specified, as using this material minimizes material cost.<sup>5</sup> Because heat exchanger B inlet piping and components operate at temperatures below 450°F, they are carbon steel; heat exchanger B outlet and all downstream piping and components (Figure 5) are required to be low alloy steel because they operate at temperatures above 500°F.

Figure 5. RHU hydrogen heat exchanger piping material requirements.

- BP did not alert the maintenance contractor that two of the three elbows were alloy steel piping components and must not be interchanged with the carbon steel elbow.
- The maintenance contractor, JV Industrial Companies, did not adequately control the disassembly, storage, and reassembly of the piping components to ensure that all the piping components were returned to their original installed locations.
- The maintenance contractor inadvertently switched carbon steel elbow 1 (Figures 2 and 5) with the alloy steel elbow 3 during the January 2005 RHU heat exchanger overhaul.

Revise the maintenance quality control program to require positive material identification testing or another suitable material verification process for all critical service alloy steel piping components removed and reinstalled during maintenance, and inform work crews of special material handling precautions.

Develop/update the written piping component installation quality control procedure to require positive material identification testing or other suitable verification or tracking process for all alloy steel piping components removed during maintenance.
