Workplace Health,
Safety and Compensation
Commission
of New Brunswick

Accident Investigation Report
on the
Explosion and Fire
at the
Irving Oil Refinery
Saint John, New Brunswick

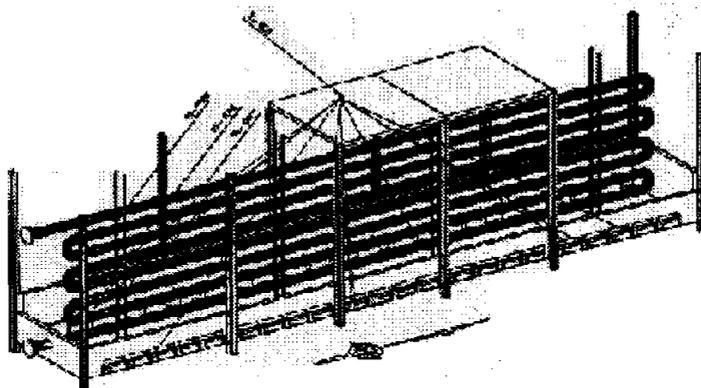
Scaled isometric view of the east cell interior, showing the tube bank and temperature sensors

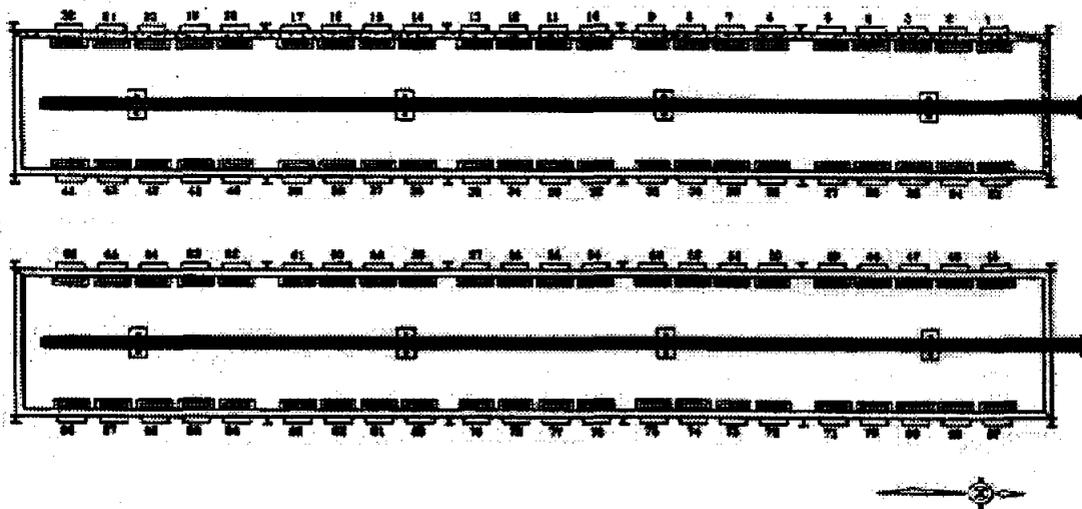
Top-down scaled plan view of radiant sections showing burner numbering system
