This Technical Paper was prepared for presentation at the *Rio Pipeline Conference & Exposition 2011*, held between September, 20-22, 2011, in Rio de Janeiro. This Technical Paper was selected for presentation by the Technical Committee of the event. The material as it is presented, does not necessarily represent Brazilian Petroleum, Gas and Biofuels Institute' opinion or that of its Members or Representatives. Authors consent to the publication of this Technical Paper in the *Rio Pipeline Conference & Exposition 2011*.

Abstract

This paper examines the lessons to be learned from the Buncefield incident for the design, maintenance and operation of tank farms.

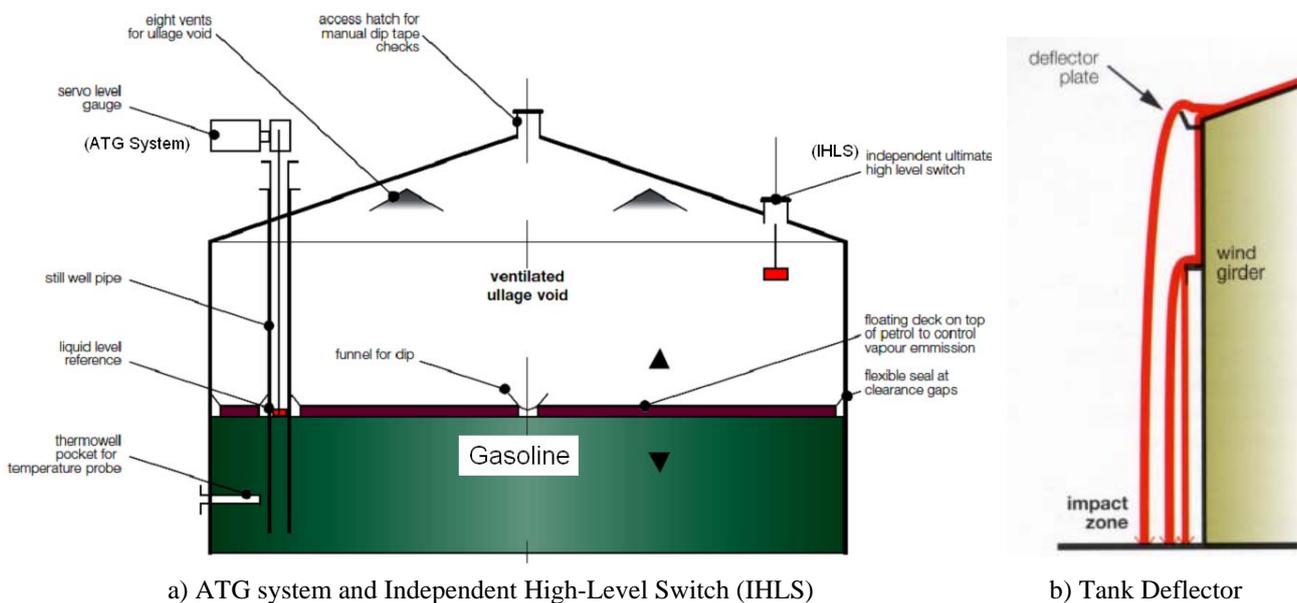
Fig.1 – Tank 912 (6,000 m³ operational load)

The immediate cause of this major incident was the failure of both the ATG and the IHLS to operate as the fuel level in Tank 912, see Fig.1. This was a loss of 'primary' containment (tank overfilling).

In July 2004, due to process safety concerns the Tank 912 received an Independent High-Level Switch (IHLS), see Fig.1a. The manufacturer had designed the switch so that some of its functionality could be routinely tested. Unfortunately, the way the switch was designed, installed and maintained gave a false sense of security. Because those who installed and operated the switch did not fully understand the way it worked, or the crucial role played by a safe padlock, the switch was left effectively inoperable after the test. The design fault could have been eradicated at an early stage if the design changes had been subjected to a rigorous review process. The manufacturer was aware that its switches were used in high-hazard installations and therefore were likely to be safety critical. Designers and suppliers should have adequate knowledge of the environments where their equipment will be used.

The tank 912 was fitted with a deflector plate, installed to direct water from sprinklers on the tank's roof to its side walls to provide cooling in the event of fire. Tests by the UK Health and Safety Executive demonstrated that the deflector plate channeled some of the escaped fuel onto the tank wall, but the rest ran over the top of the plate, fragmenting into droplets that cascaded through the air. Most of the fuel running down the wall hit a wind girder (a structural stiffening ring) and detached from the tank wall, creating a second cascade of droplets, see Fig.1b.

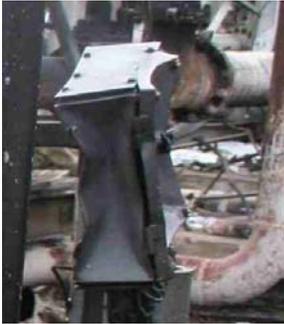
a) Crushed electrical connection box

Damaged lightweight steel junction boxes, Fig.2a, on the site located within the area covered by the gas cloud were compared with similar boxes tested under a range of different loading conditions using hydrostatic pressure, gas explosions and High Explosive charges (HE). Analysis of these results has shown that the minimum magnitude of overpressure required to cause damage comparable to that sustained by junction boxes on the Buncefield site is of the order of 2 bar with duration ~ 50 ms. At shorter durations that are more representative of overpressure within a detonating gas cloud (~ 10 ms), an overpressure of 5 bar would be required.

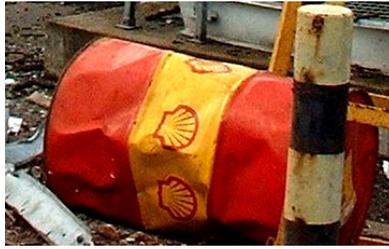
b) Crushed oil drum

An empty oil drum, Fig.2b, sustained inward plastic deformation (crushing) to its walls, Fig.2a, and buckling of the drum end. A similar damage pattern was caused in a hydrostatic pressure test at pressures of between 1.5 and 2 bar. A gas explosion with a maximum overpressure of 1.8 bar on an empty drum produced a smaller magnitude but similar deformation pattern in the end plate of the drum.

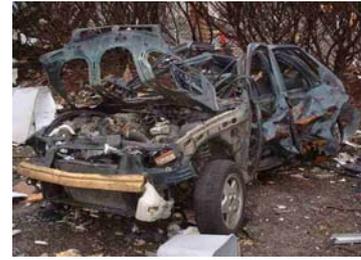
c) Crushed car

Over 20 cars were in the area covered by the gas cloud and all were badly crushed. Comparative tests using HE have shown that overpressures of the order of 10 bar were required to cause the level of damage observed at Buncefield (see Fig.2c). Comparative gas explosion tests in a strong steel enclosure in which cars were subjected to overpressures of 1bar resulted in significantly less damage that observed at Buncefield. It is concluded from examining all the data available that the overpressures experienced by cars at Buncefield exceeded 2 bar for durations ~ 50 ms.

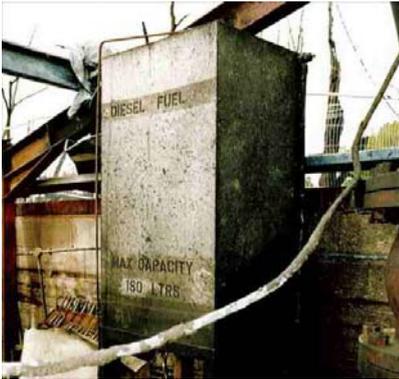
d) Diesel tank in pump house

On the emergency pump house, where the explosion is thought to have started, contained a number of lightweight metal objects that sustained minimal damage (Fig. 2d). This suggests that in its initial phase, the explosion overpressure was modest.

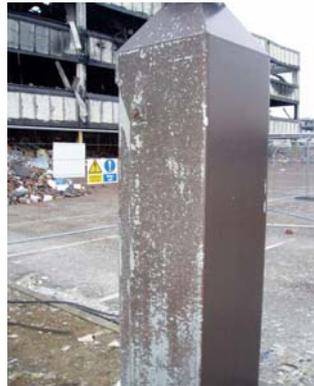
e) Post in car park

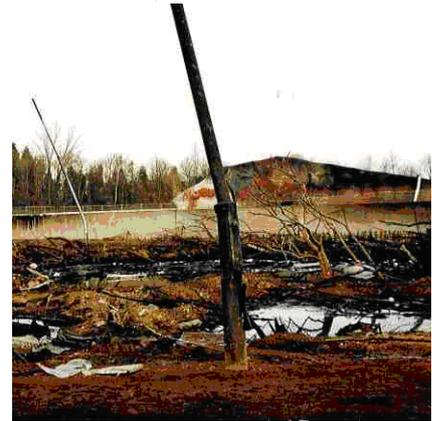
f) Deflected lamp post

A number of objects on site were susceptible to drag forces (e.g. lamp posts, fence posts, camera masts, trees). An example can be seen in Fig.2f. The deformation exhibited by such objects provided information on the net drag impulse sustained by these objects. Other directional evidence was provided by the directional abrasion found on one side or one part of painted surfaces of post in car parks, as in Fig.2e. There was also evidence of large objects such as cars and skips being displaced in a particular direction.

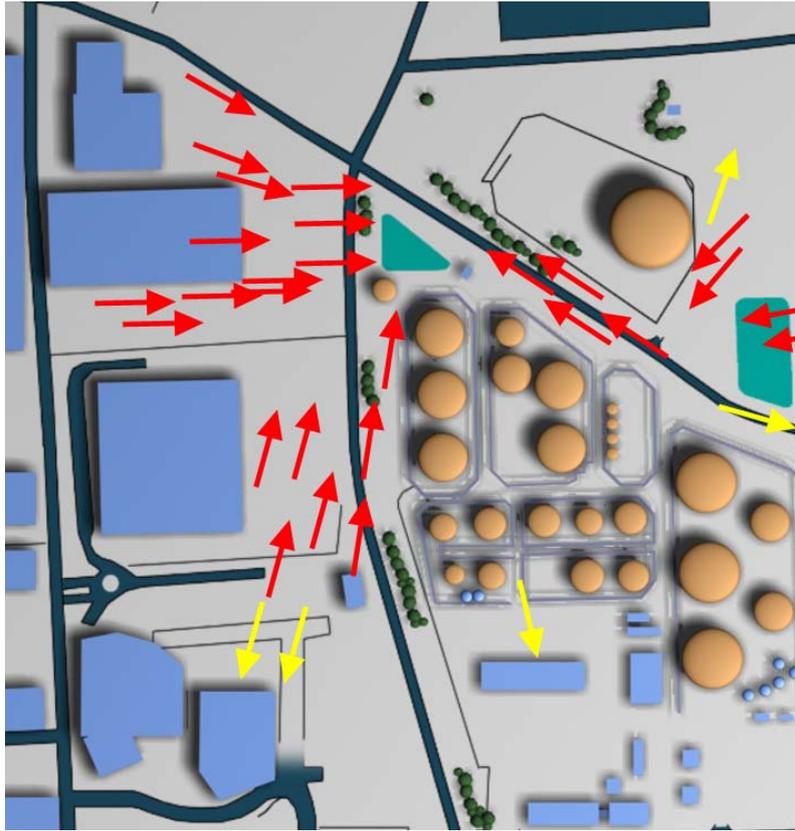
Fig.3 – Net drag impulse direction across the site

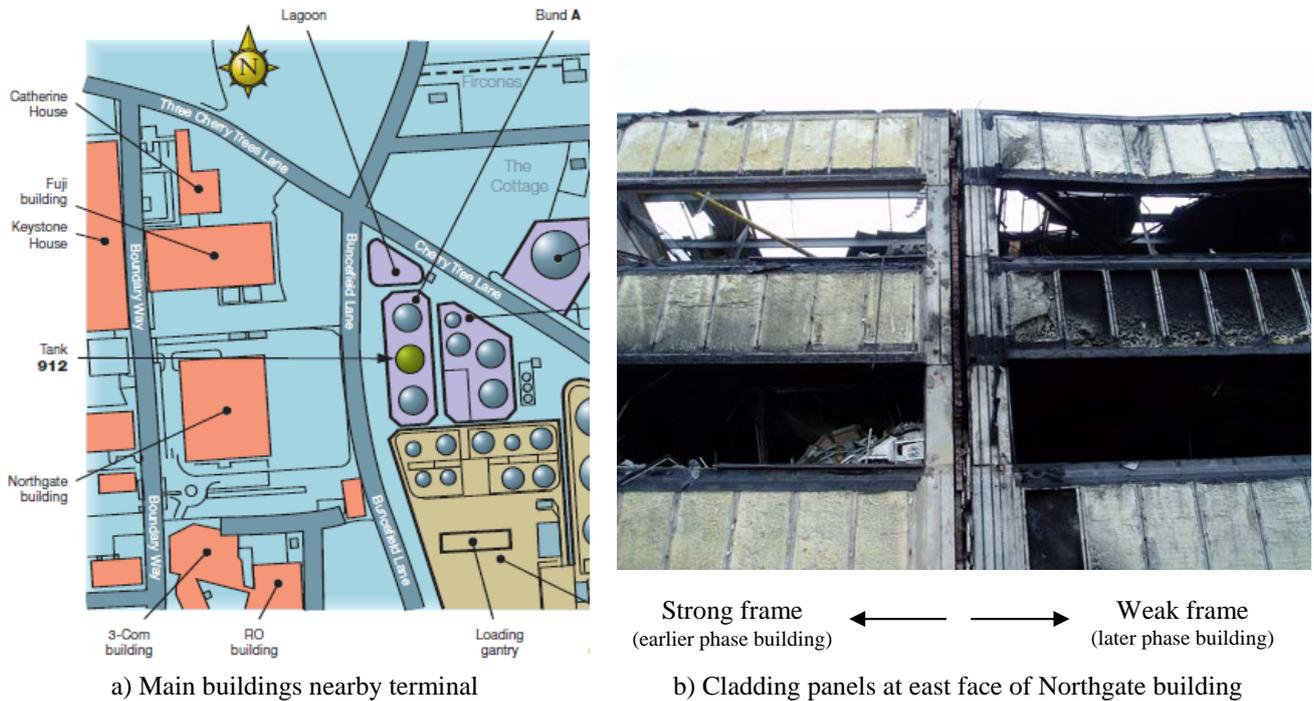
Fig.4 – Damage to nearby buildings

An assessment of damage to the RO Building (a minimum of 50 m from the edge of the cloud), see Fig.4a, concluded that there was:

1. Severe (80-100%) loss of glass windows to the east and north elevations with frame damage on the north elevation;
2. Minimal damage to the perimeter of exterior walls;
3. Minimal or no damage to the building structural frame.

The assessment concluded that an overpressure of 0.2 bar at the North East corner of the building was capable of generating the observed levels of damage.

The Northgate Building had been built in two phases at different times. The cladding panels used in the two phases were architecturally identical. However, examination of failed panels revealed that the earlier phase panels contained less reinforcement than those used in the second phase. This difference manifested itself in the response of these panels to the explosion. Two adjacent panels at the top floor level – one on the earlier phase and the other on the later phase were found to have deflected by 200mm and circa 30mm respectively, see Fig.4b.

The load profile found to cause damage consistent with that observed in both panels has a rise time equal to 30% of the overall duration and a decay equal to 70% of the overall duration. Assessment of the sensitivity of the response to variation in the properties of the reinforcing bar yielded a peak pressure of 0.16 bar when using design values for the steel strength and 0.3 bar when using measured steel strength (from samples taken from site after the accident). The associated load durations were 1.6s and 0.6s respectively. Furthermore, it was found that the damage caused is very sensitive to the magnitude of peak pressure but much less sensitive to the magnitude of the impulse.

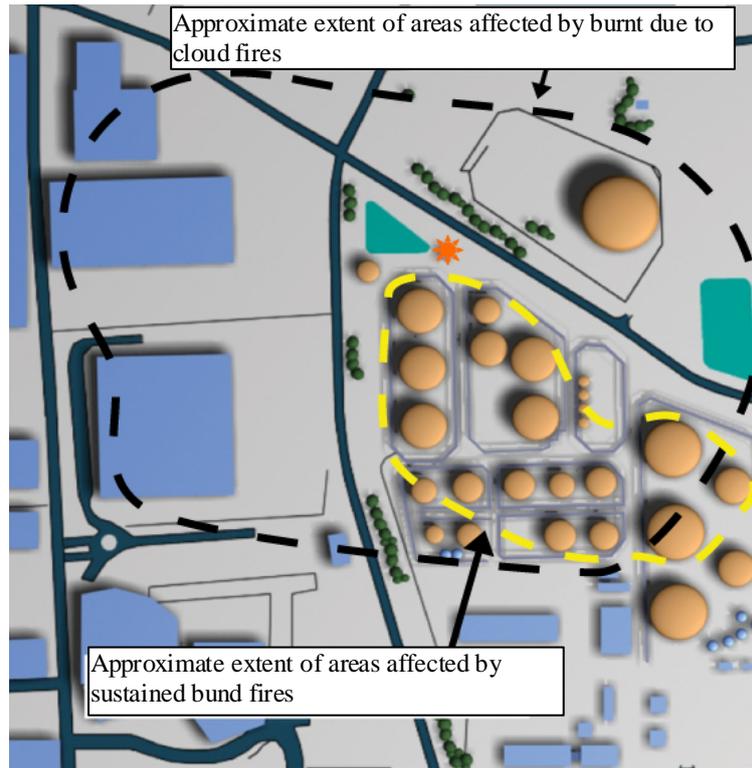
Burning of vegetation caused by the combustion of the vapour cloud enabled the cloud's location to be estimated, see Fig.5. The area covered by the cloud is approximately 120,000 m² (flammable cloud with average radius of 196m). CCTV images enabled the average depth of the cloud to be estimated as 2 m (assuming that the flammable limit corresponds closely to the top of the mist). The volume of the cloud with a concentration above the lower flammable limit (LFL) is therefore in the region of 240,000m³. Based on tank inventory information, the chemical composition of the cloud is similar to butane or propane in terms of reactivity.

Fig.5 - Extent of flammable cloud (ignition location denoted by ★)
